Route 1 and Route 172, Ellsworth

Node #23871

CRF (2013-2015) 2.27

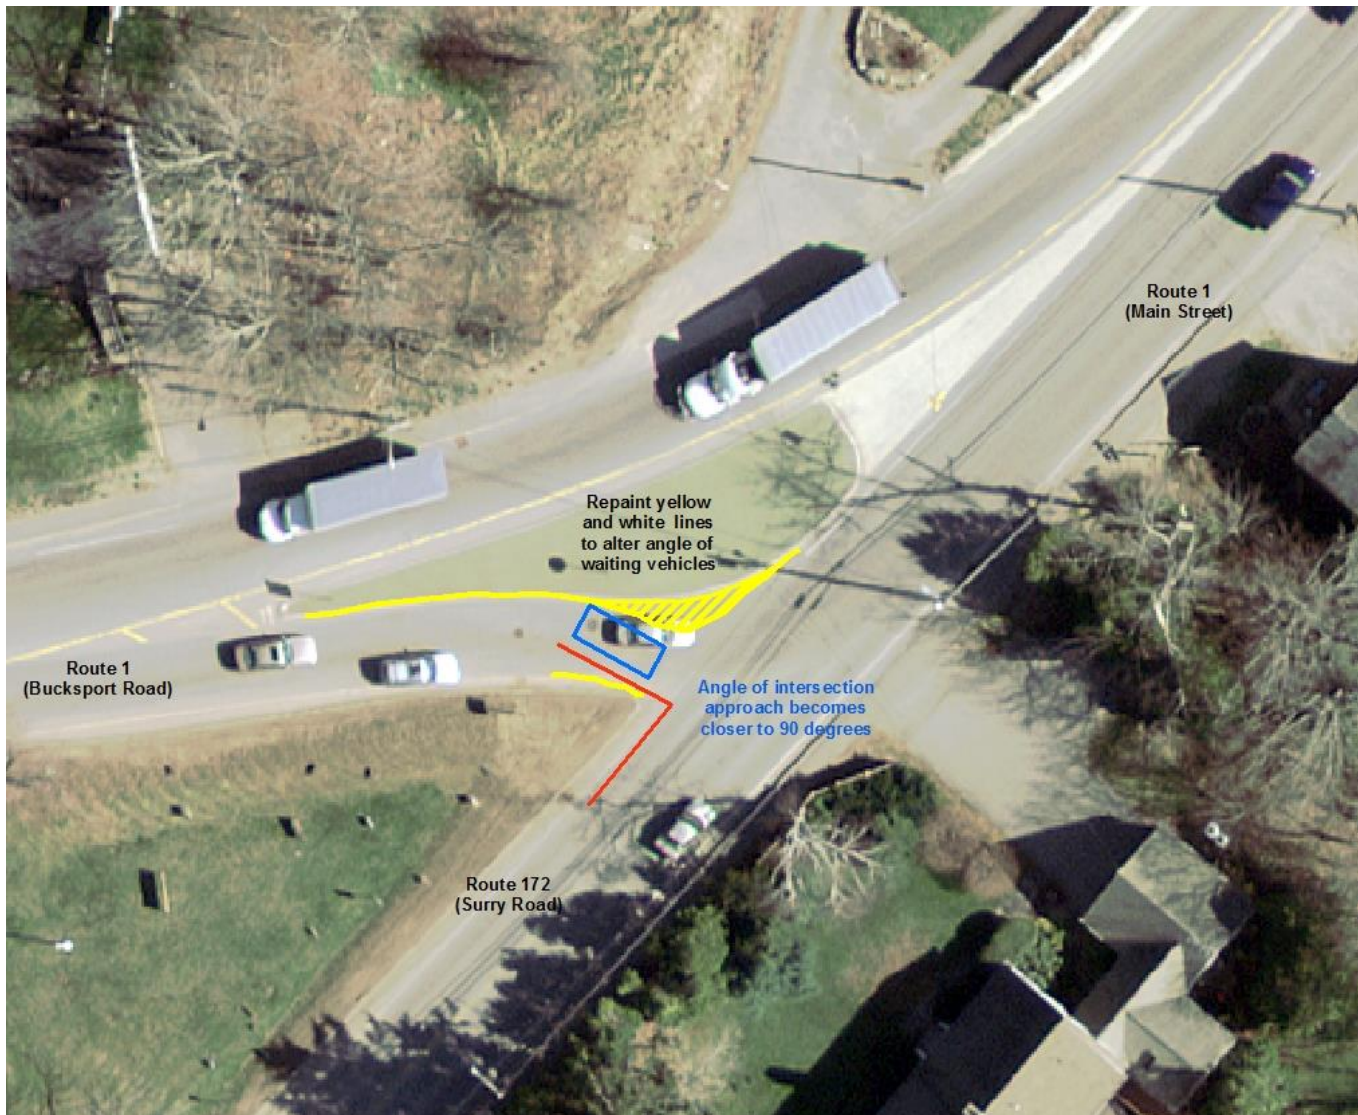
Photo B. Repaint the yellow lines at the intersection so that vehicles stop at closer to a right angle.

1. Repaint the yellow and white lines at the intersection to adjust the angle at which Route 1 traffic approaches the intersection from the west, so that vehicles stop at closer to a right angle (see Photo B).

2. Reconstruct the intersection to adjust the angle at which Route 1 traffic approaches the intersection from the west, so that vehicles stop at closer to a right angle.
