## Route 1 and Route 172, Ellsworth

Node #23871

CRF (2013-2015) 2.27

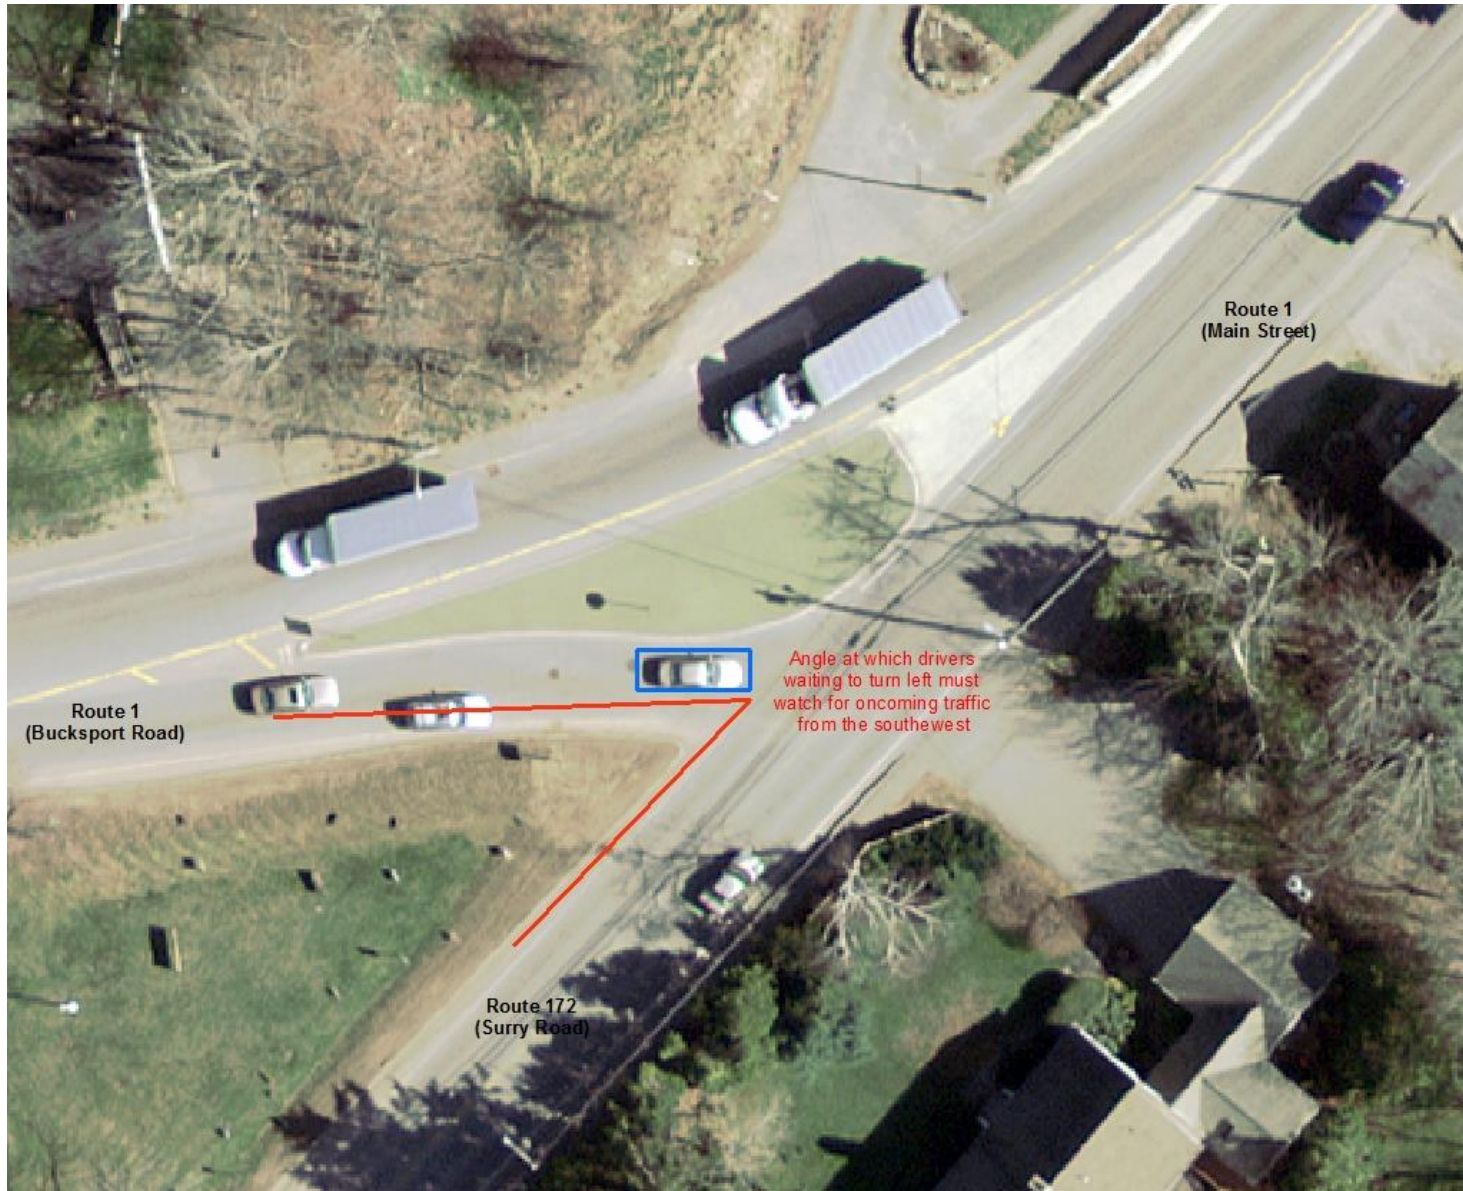
Traffic traveling through on Route 1 from the west to the northeast arrives at this intersection at an awkward angle (see photo A). Eastbound drivers on Route 1 must watch for traffic from Route 172 to the southwest involves significant turning of the head, and often in-vehicle obstacles such as seat belts, headrests, and window dividers impair vision. A driver turning that far to the right limits their peripheral vision to the left, as well. Drivers waiting in this position to turn left must watch oncoming traffic from the northeast, which approaches quickly up a hill, and traffic from the southwest, for an opening in which they can negotiate a turn. Drivers may inch further into the intersection to improve their line of sight, creating a hazard to northeast-bound traffic on Route 172. Five of the 12 crashes at this node were related to eastbound vehicles negotiating a left turn at the intersection colliding with southwest-bound oncoming traffic.

Route 1 drivers following behind a vehicle waiting to turn left at the intersection may see the vehicle in front start to go, turn far to the right to see if they too are clear to go, and start to roll forward only to realize that the vehicle in front of them did not, in fact, complete the turn as assumed. Five of the 12 crashes at this node were related to eastbound vehicles on Route 1 waiting to turn left colliding with the rear of a vehicle in front of them.

**Photo A.** Traffic traveling through on Route 1 from the west to the northeast arrives at this intersection at an awkward angle.

1. Repaint the yellow and white lines at the intersection to adjust the angle at which Route 1 traffic approaches the intersection from the west, so that vehicles stop at closer to a right angle (see Photo B).

2. Reconstruct the intersection to adjust the angle at which Route 1 traffic approaches the intersection from the west, so that vehicles stop at closer to a right angle.

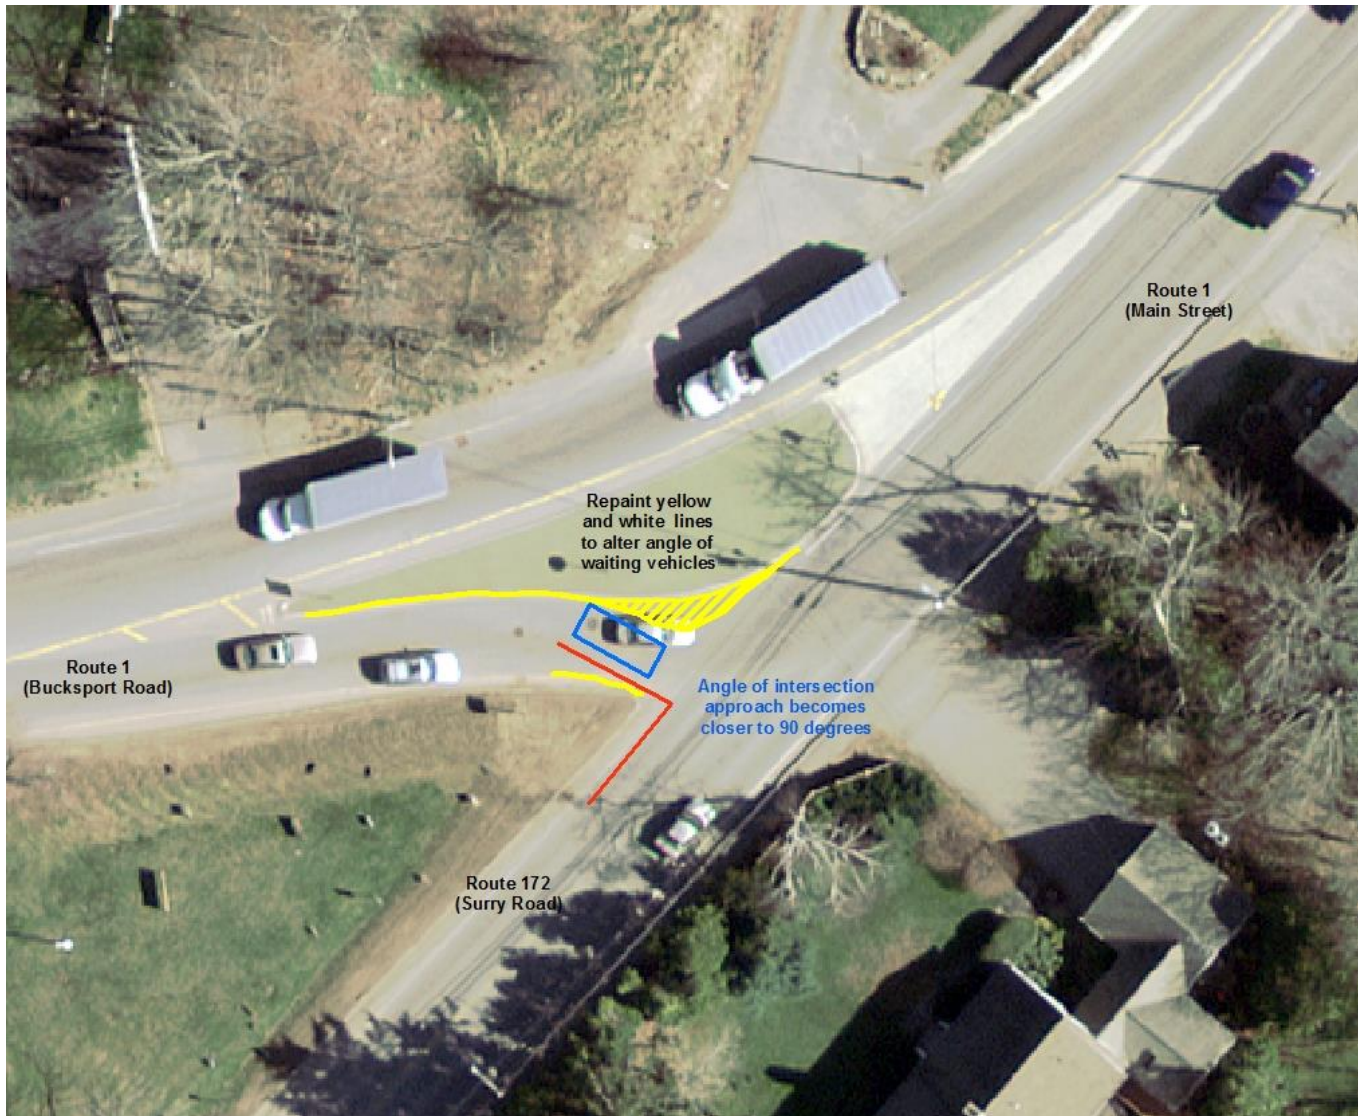
**Photo B.** Repaint the yellow lines at the intersection so that vehicles stop at closer to a right angle.

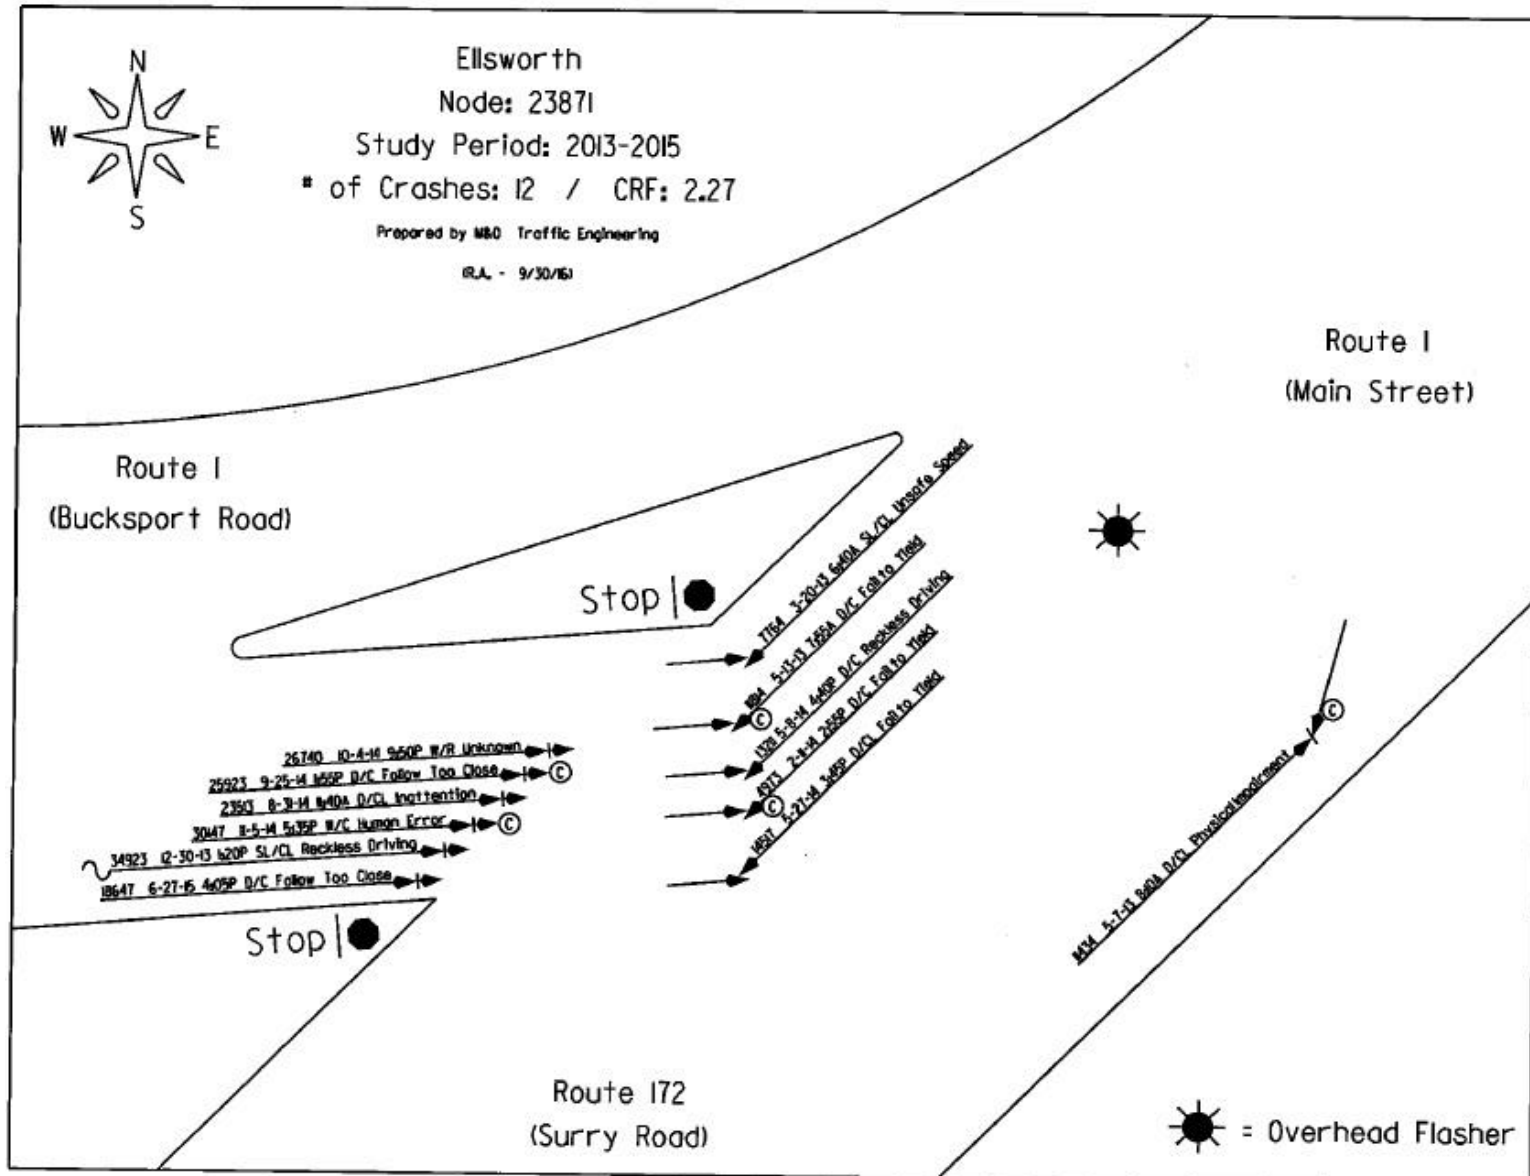
Appendix A. Summary Crash Diagram

Route 1 & 3 serves as a main route for commercial, commuter, and tourist traffic connecting Downeast Maine with all points south. Route 1 is locally known as Bucksport Road west of the intersection, which is two-way, and Main Street east of it, where it is a three-way street with two lanes of oncoming traffic that split into a lane heading west, towards Bucksport, a lane heading south, towards Surry, and a lane of northeasterly traffic heading towards downtown Ellsworth. Route 1 intersects Route 172 (known locally as the Surry Road), a two-lane street that runs between Downtown Ellsworth and the Blue Hill Peninsula. The intersection experiences heavy traffic loads year-round, and was redesigned several years ago. There were 12 crashes reported at this location between January 2013 and December 2015 (see Appendix A).
