Short Street and High Street, Ellsworth

Node #23990

CRF (2013-2015) 1.86

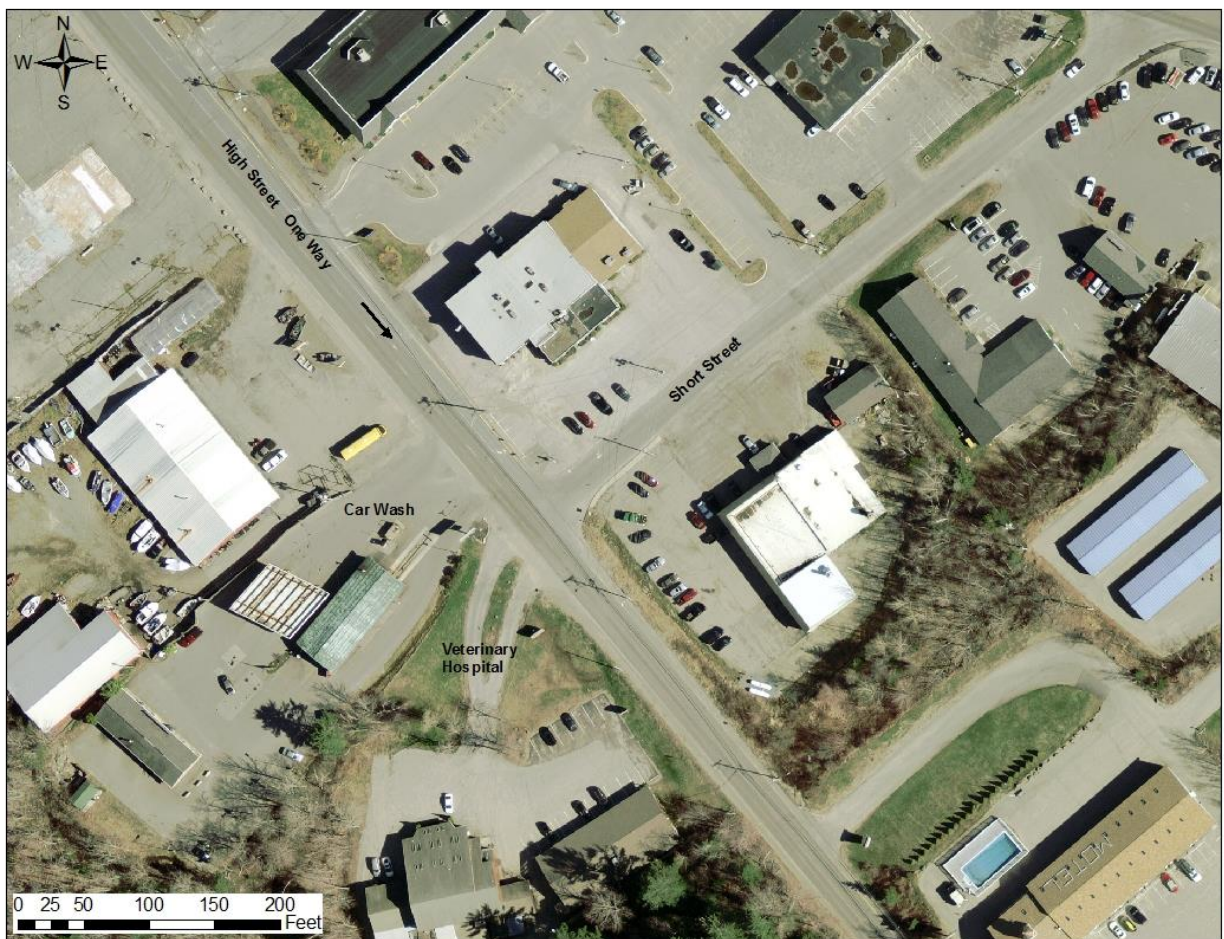
Short Street is a two-way city street that intersects Route 3 (High Street), a one-way, with two travel lanes and a left turn lane for turning onto Short St. 65 feet prior to Short Street (opposite side of Route 3 from Short Street) is the entrance to a car wash/gas station, which is popular due to its reputation for low fuel prices. 65 feet beyond the car wash/gas station entrance (directly across from Short Street) is the entrance to a veterinary hospital. These two business have separate entrances. This section of Route 3 is subject to heavy traffic volumes comprised of shipping, local business and tourist traffic, as it offers access to a variety of “big box” retail stores, local business and serves as the primary route to the MDI/Bar Harbor/Acadia region. There were nine crashes reported at this intersection between January 2013 and December 2015 (see Appendix A).

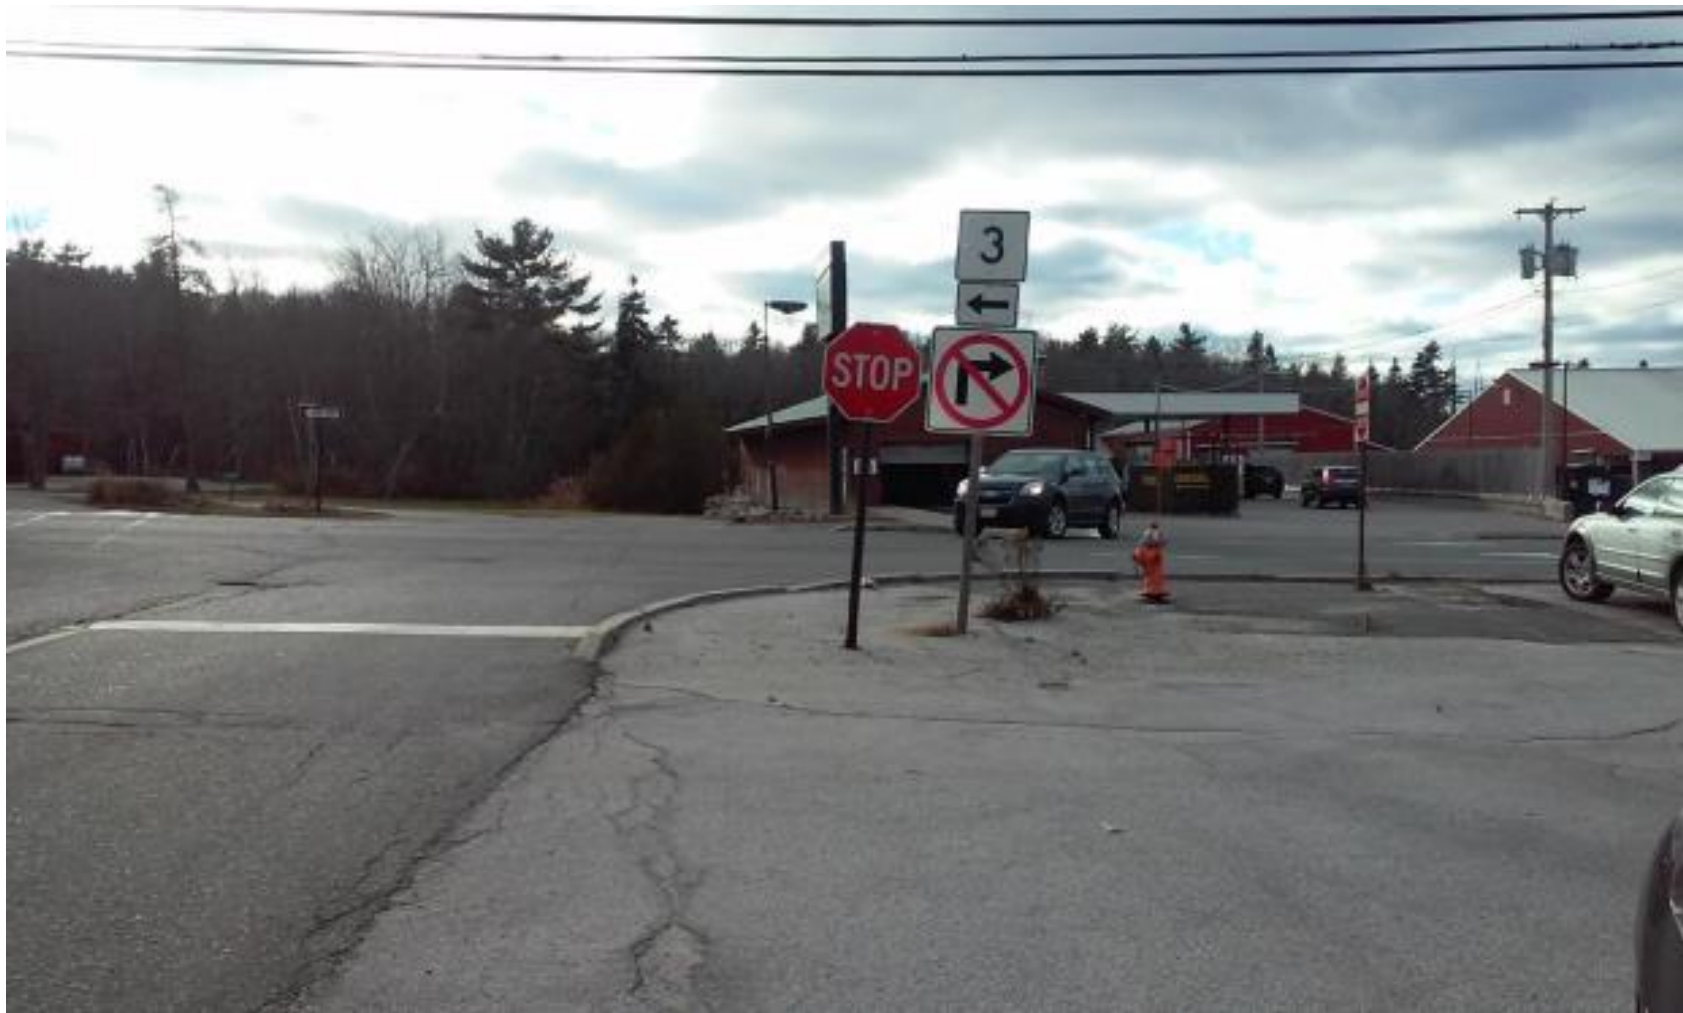
Because Short Street is the “last chance” to exit the one-way section of High Street, and connects Routes 1 & 3, many patrons of the car wash and veterinary hospital cross Route 3 to get onto Short Street. From the Car Wash, this involves cutting across three lanes of one-way traffic (see Photo A). From the veterinary hospital, it involves going the wrong way on a one-way across two lanes of traffic. Vehicles also regularly cross High Street from Short Street to get to the car wash, going the wrong way for 65 feet or for 25 feet and entering the exit. Five of the nine crashes reported at this location involved vehicles crossing Route 3 from the car wash to Short Street, and one involved a crossing from the veterinary hospital to Short Street.

Photo A. Car wash patrons often travel across three lanes of traffic on High Street to get to Short Street.

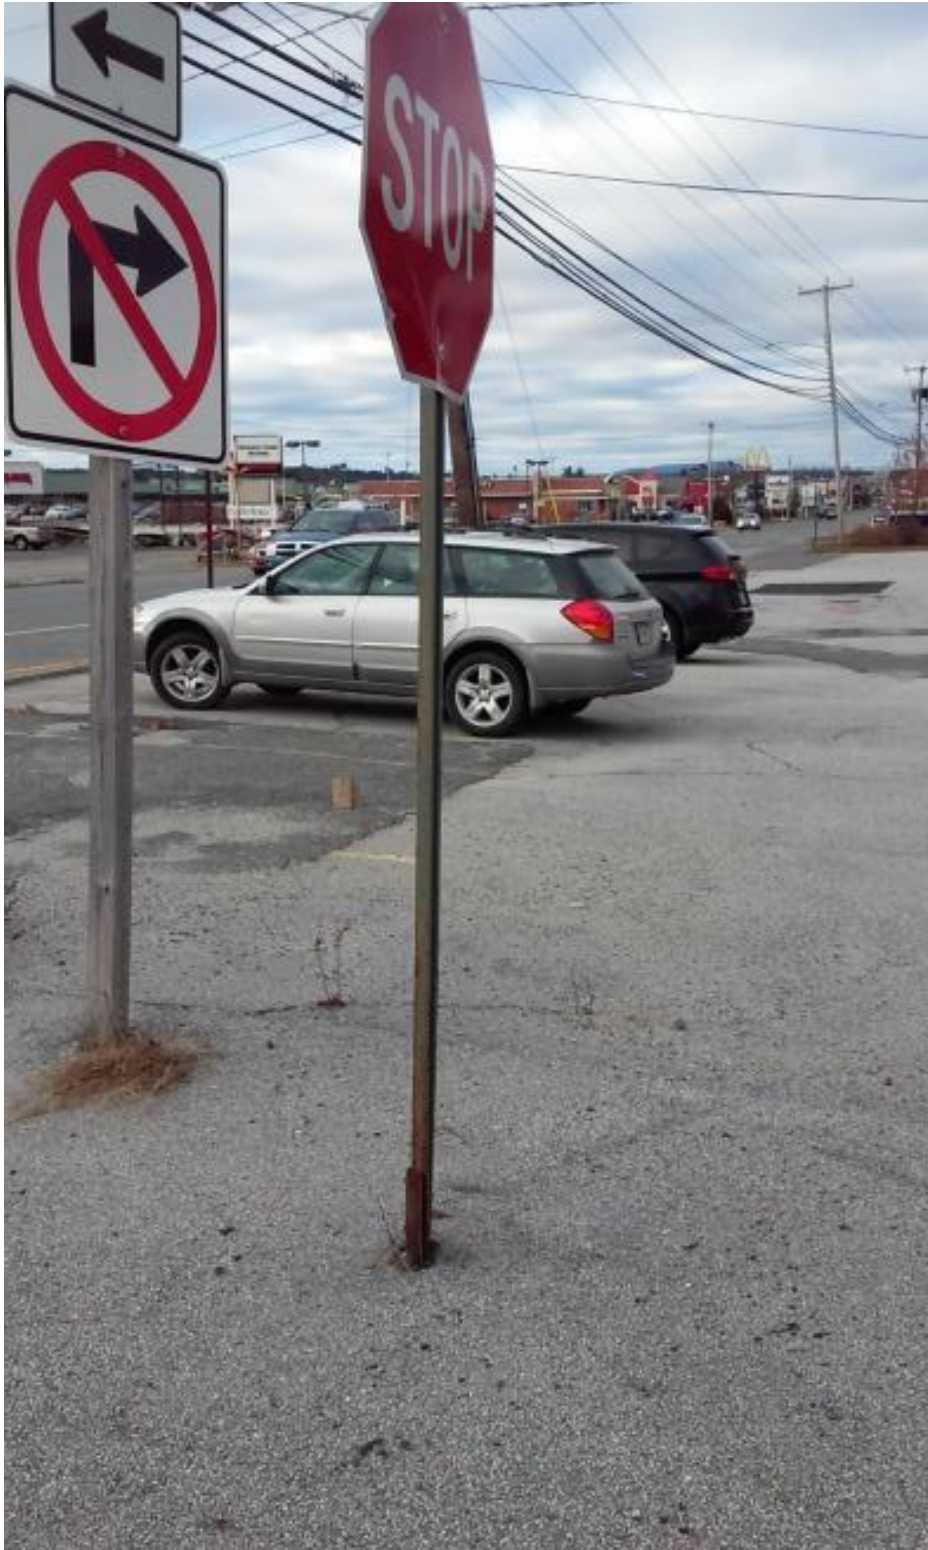
Sight obstructions to the northwest can make it difficult for traffic exiting Short Street to do so safely from the existing location of the stop sign & stop line. From the painted stop line on Short Street looking northwest a sign, parked vehicles, and snow storage in the winter months, can limit the visibility of traffic on High Street (see Photo B). These obstructions restrict sight of traffic in the left designated turn lane for vehicles turning onto Short Street and the lane that they are entering (the left through lane). The limited visibility causes drivers on Short Street waiting to pull out to creep closer to the end of the road in an effort to see when they have a clear window to pull out (see Photo C). Traffic in the far left lane turning from Route 3 onto Short Street regularly cuts short the turn, cutting into the lane where entering traffic may be waiting (see Photo D). The combined factors of waiting vehicles creeping further into the intersection to enhance visibility (without curbing adjustments), wrong way movements onto Route 3 from Short Street into the car wash and traffic turning tightly onto Short Street from Route 3, creates risk. One crash evidenced this scenario within the 2013-2015 study period.

Photo B. Motorists on Short Street waiting to turn face numerous barriers to visibility, making it hard to judge when it is safe for them to proceed.

1. Modify the southwest bound entrance to eastbound Route 3
 - a. The double yellow line on Short Street and the painted stop line should be brought towards Route 3, approximately 3 feet behind the curbline. These changes will allow southwest bound Short Street traffic to see without obstruction to the northwest, as well as provide visual cues to traffic turning onto Short Street from Route 3, encouraging vehicles to turn cleanly into the northeast bound travel lane (see Photo F).

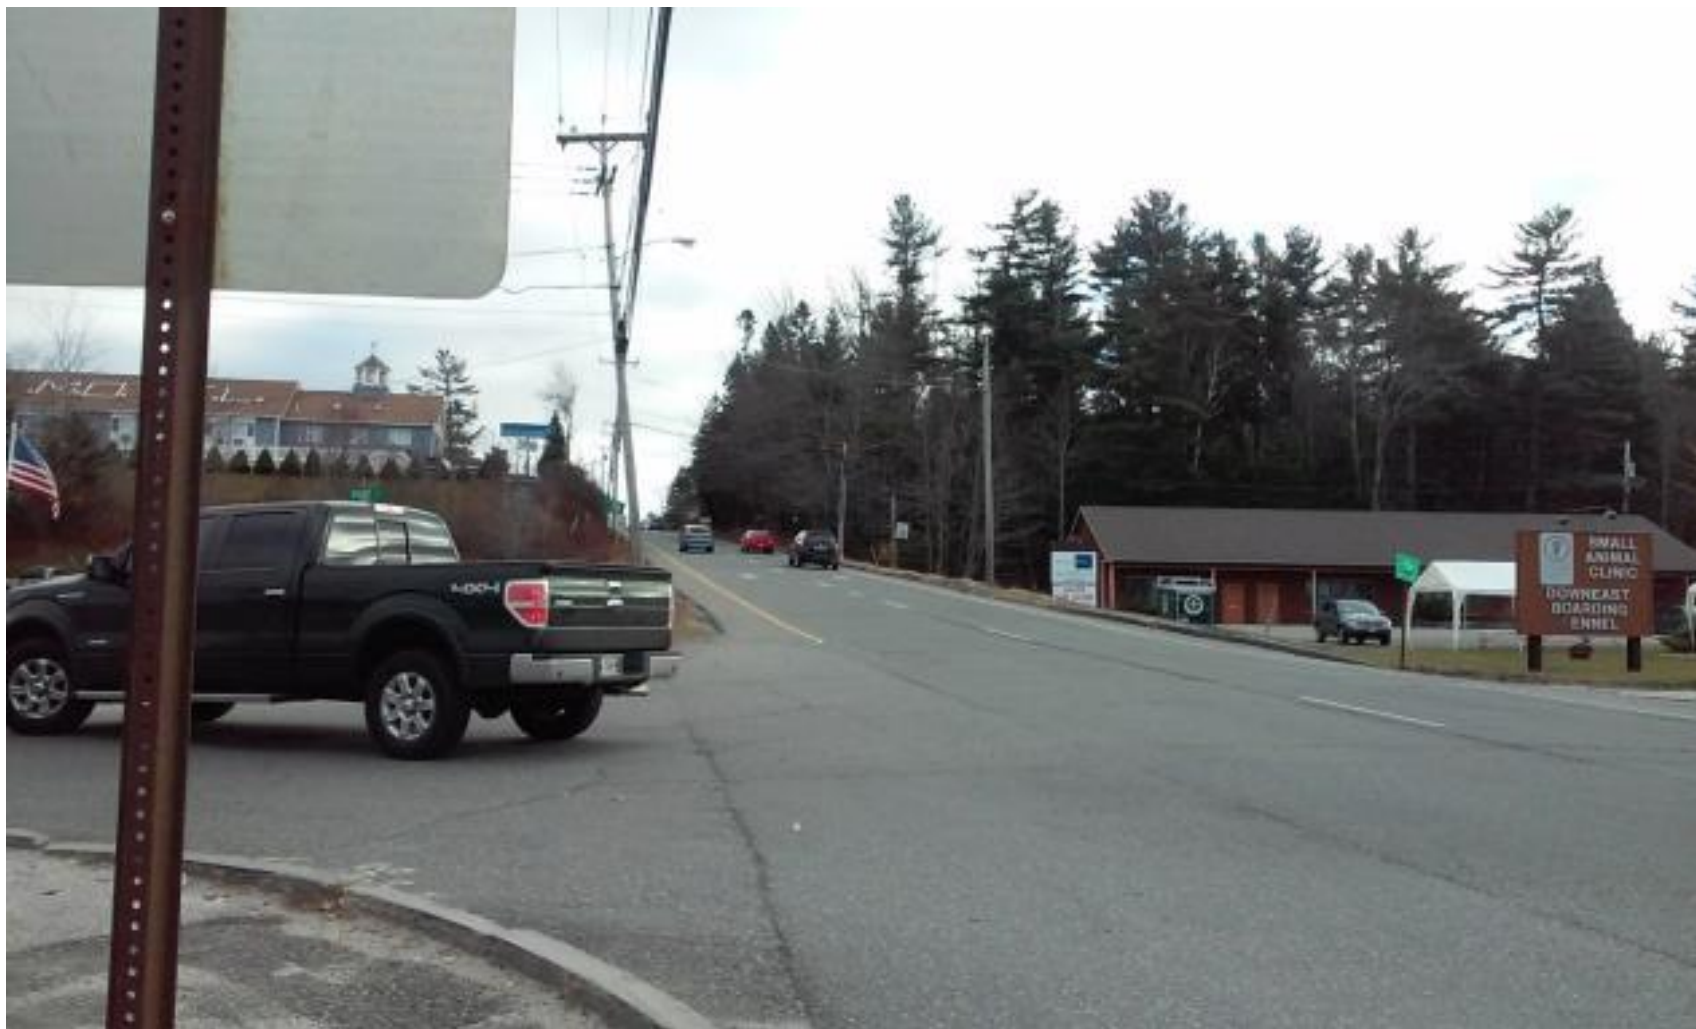
Photo D. Motorists turning onto Short Street from High Street often make a shallow turn, causing them to drift into the lane where turning traffic waits.

3. Redesign and construct a right-angled curb at Short Street to discourage traffic from turning right, entering the one way going the wrong way (from Short Street to the car wash). This change will also provide a physical barrier protecting traffic turning onto Route 3 from traffic turning left onto Short Street from east bound Route 3 in the left turn lane. (see Photo H).

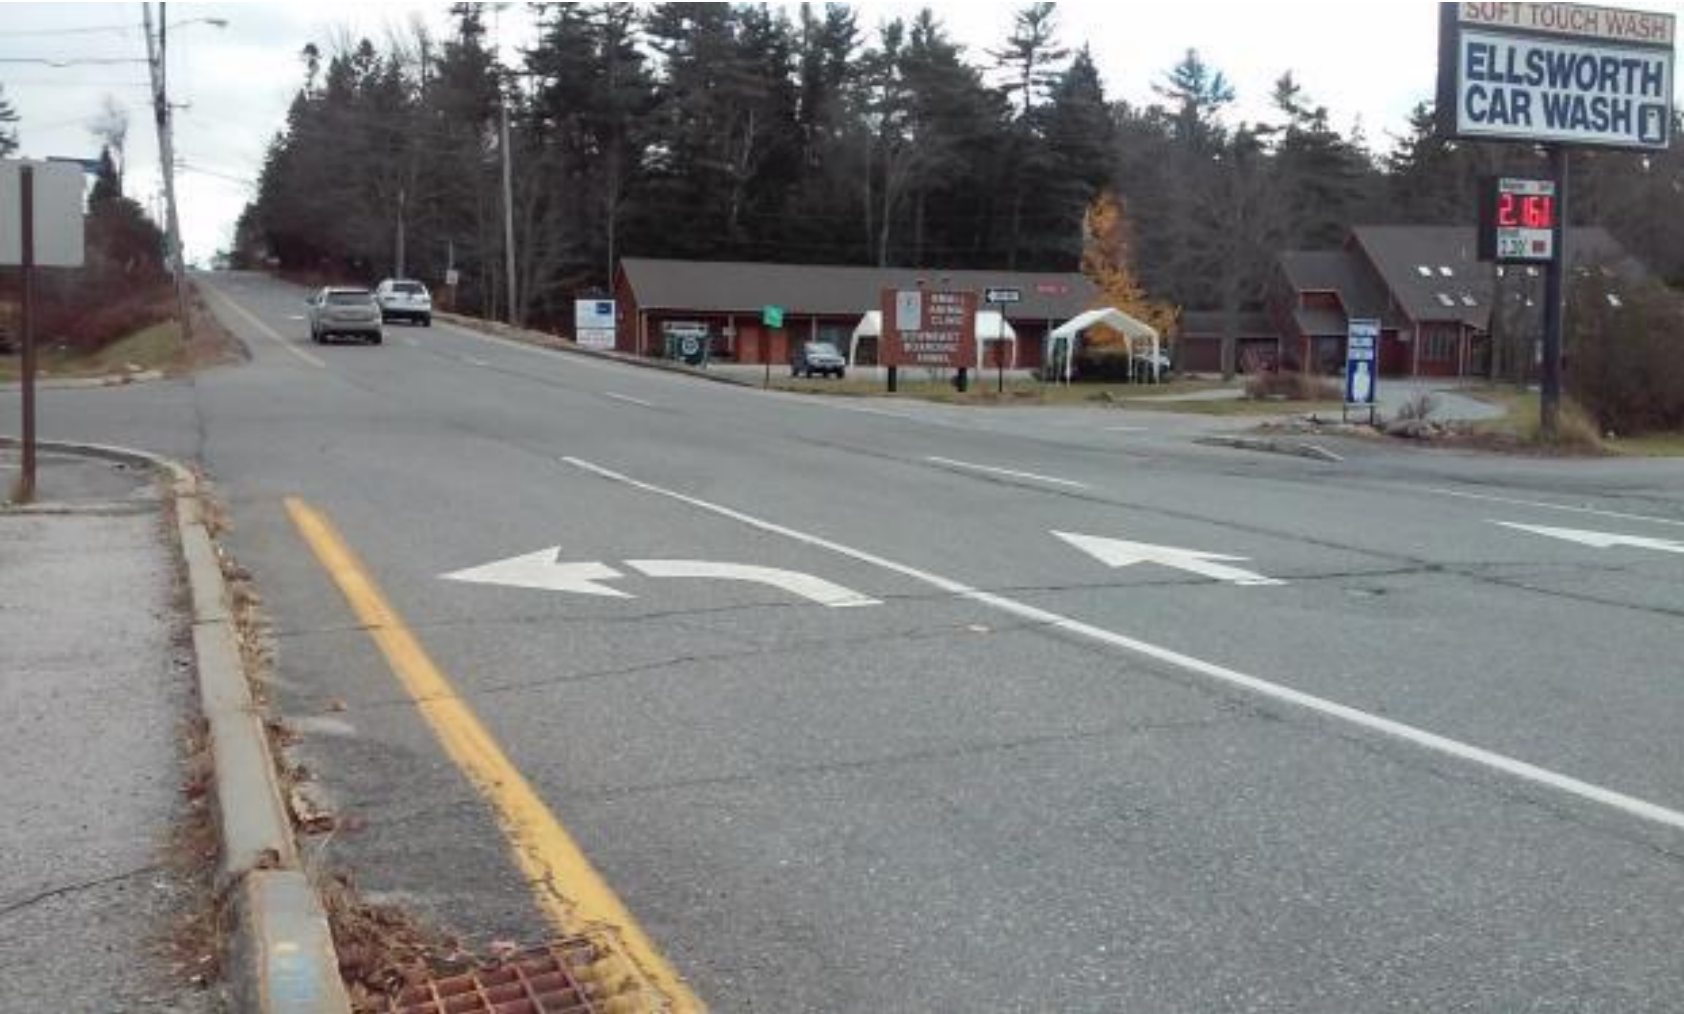
Two additional crashes at this node were associated with vehicles performing lane changes while traveling this section of High Street, which has three lanes up to Short Street, and two lanes thereafter (see Photo E).

Photo E. This section of High Street, which has three lanes up to Short Street, and two lanes proceeding south.

4. Enhanced Signage

- a. Improve overhead lane designation signage with destination signage
- b. Install roadside signage on the left & right of Route 3 to reduce unnecessary lane changes along this one-way stretch.

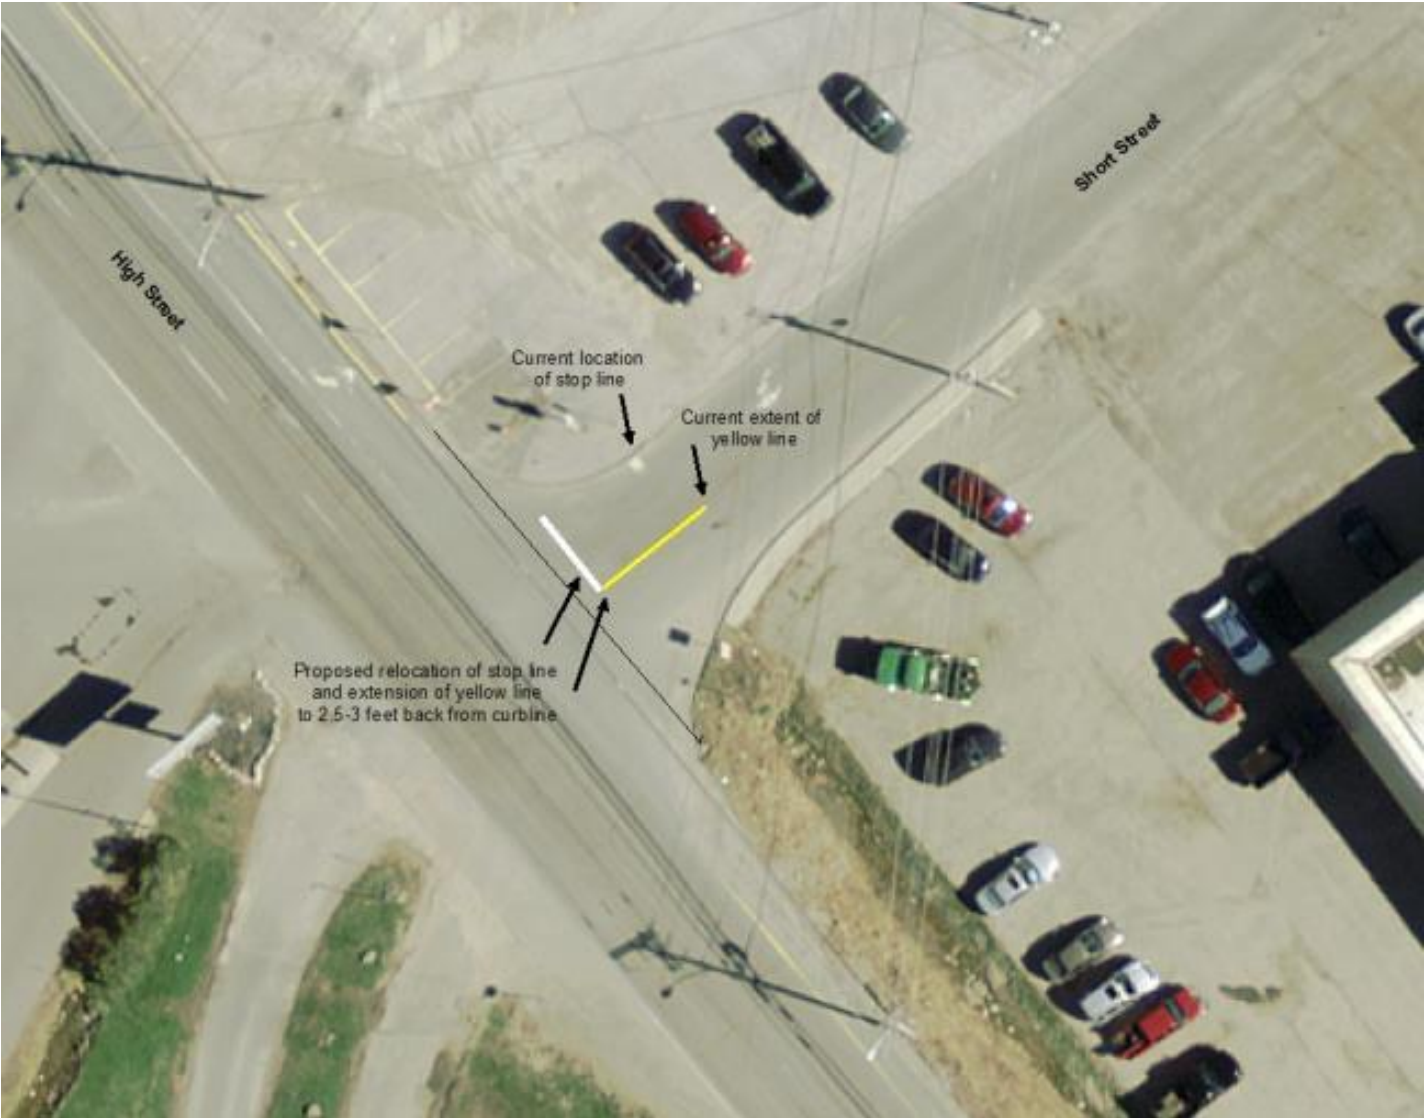
Photo F. Relocate the stop line and extend the yellow line on Short Street.

- b. Relocate the stop sign for southwest bound Short Street to 3 feet northeast of the left turn lane curb line.
2. The car wash’s street-level “Propane Fill Station” sign between the entrances for the car wash and the veterinary hospital should be relocated to enhance visibility of oncoming traffic for vehicles exiting the veterinary hospital (see Photo G).

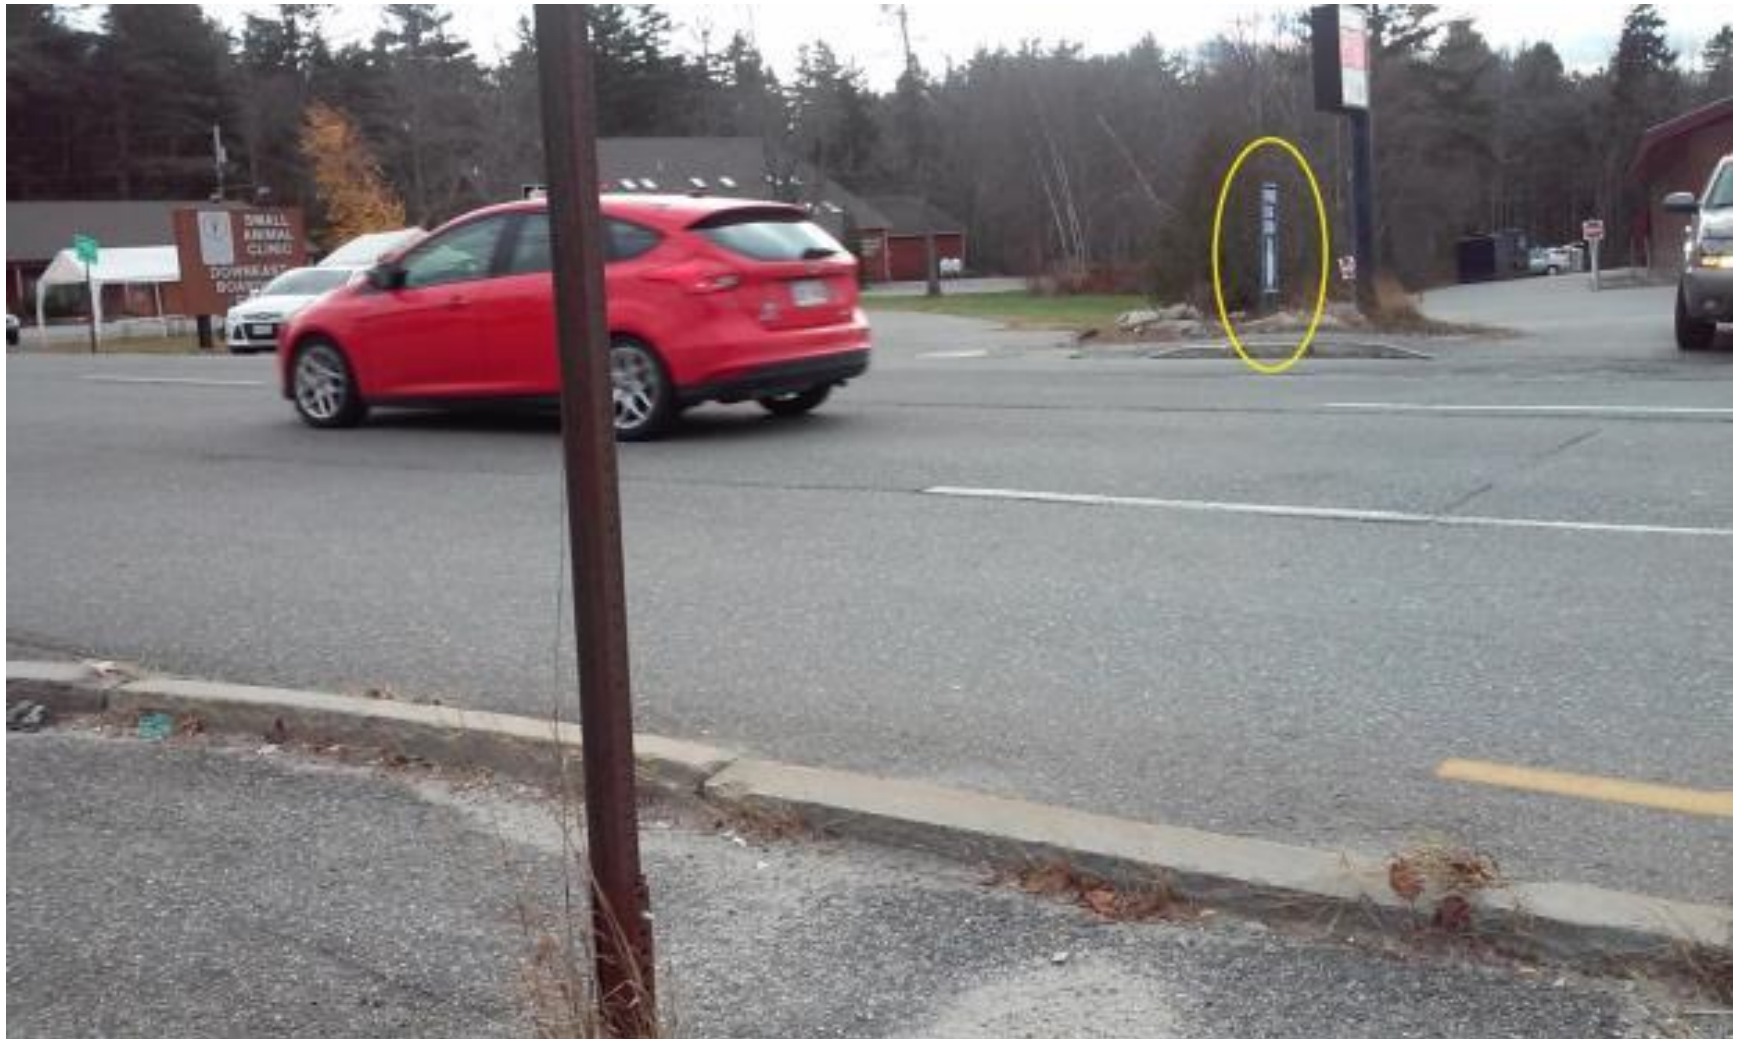
Photo G. Relocate the street-level sign on High Street.

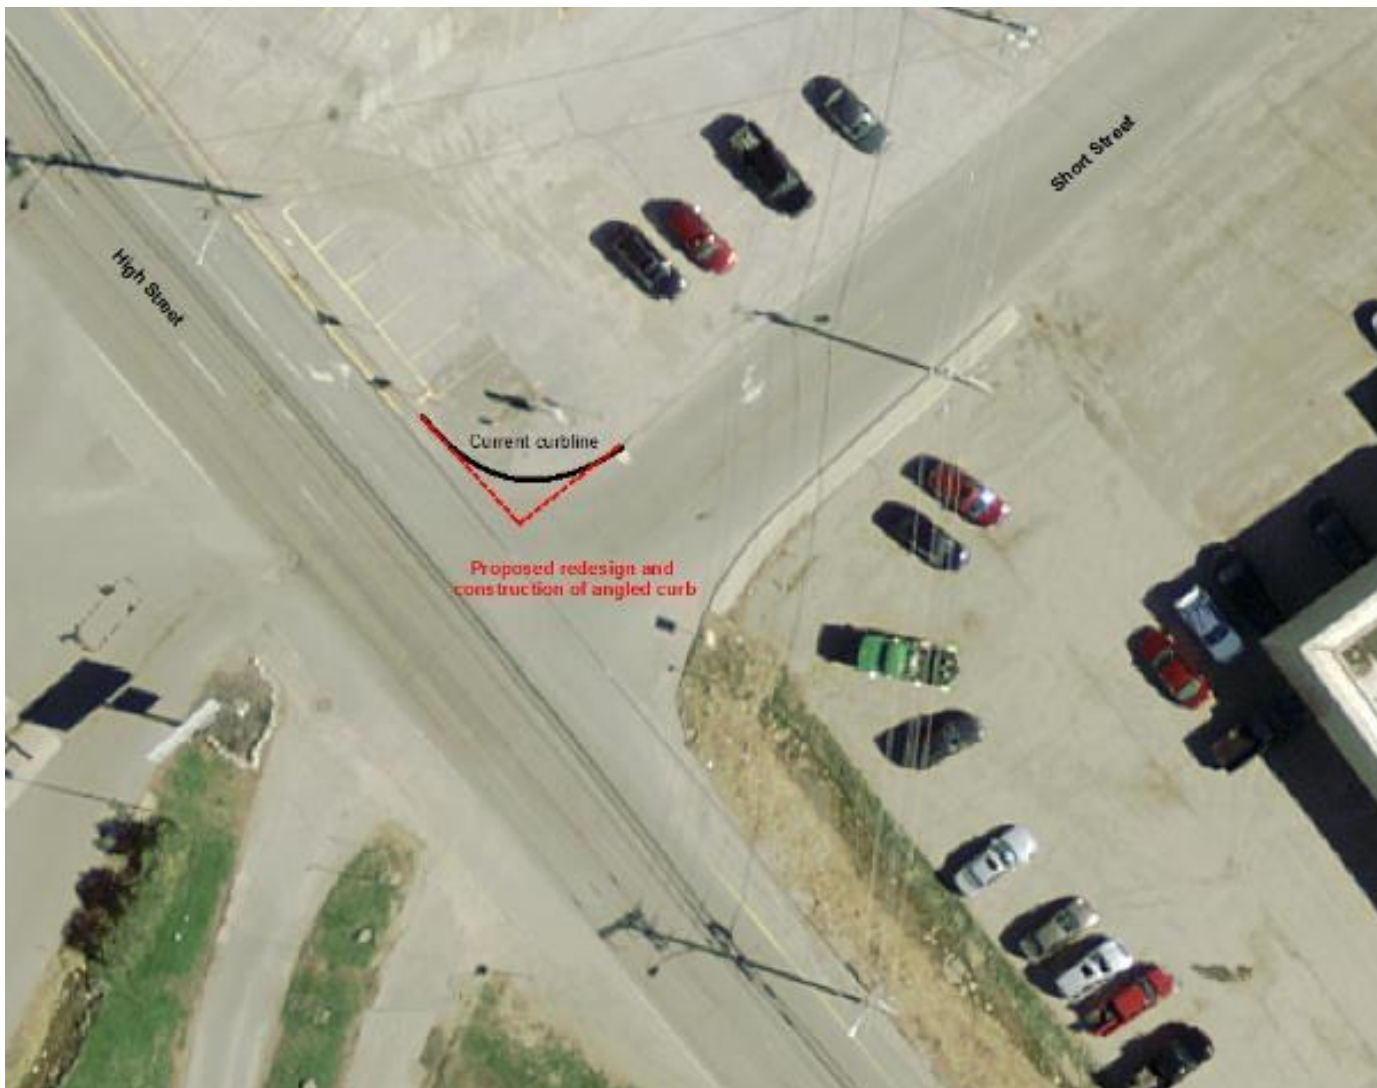
Photo H. Redesign and reconstruct the curb on Short Street.

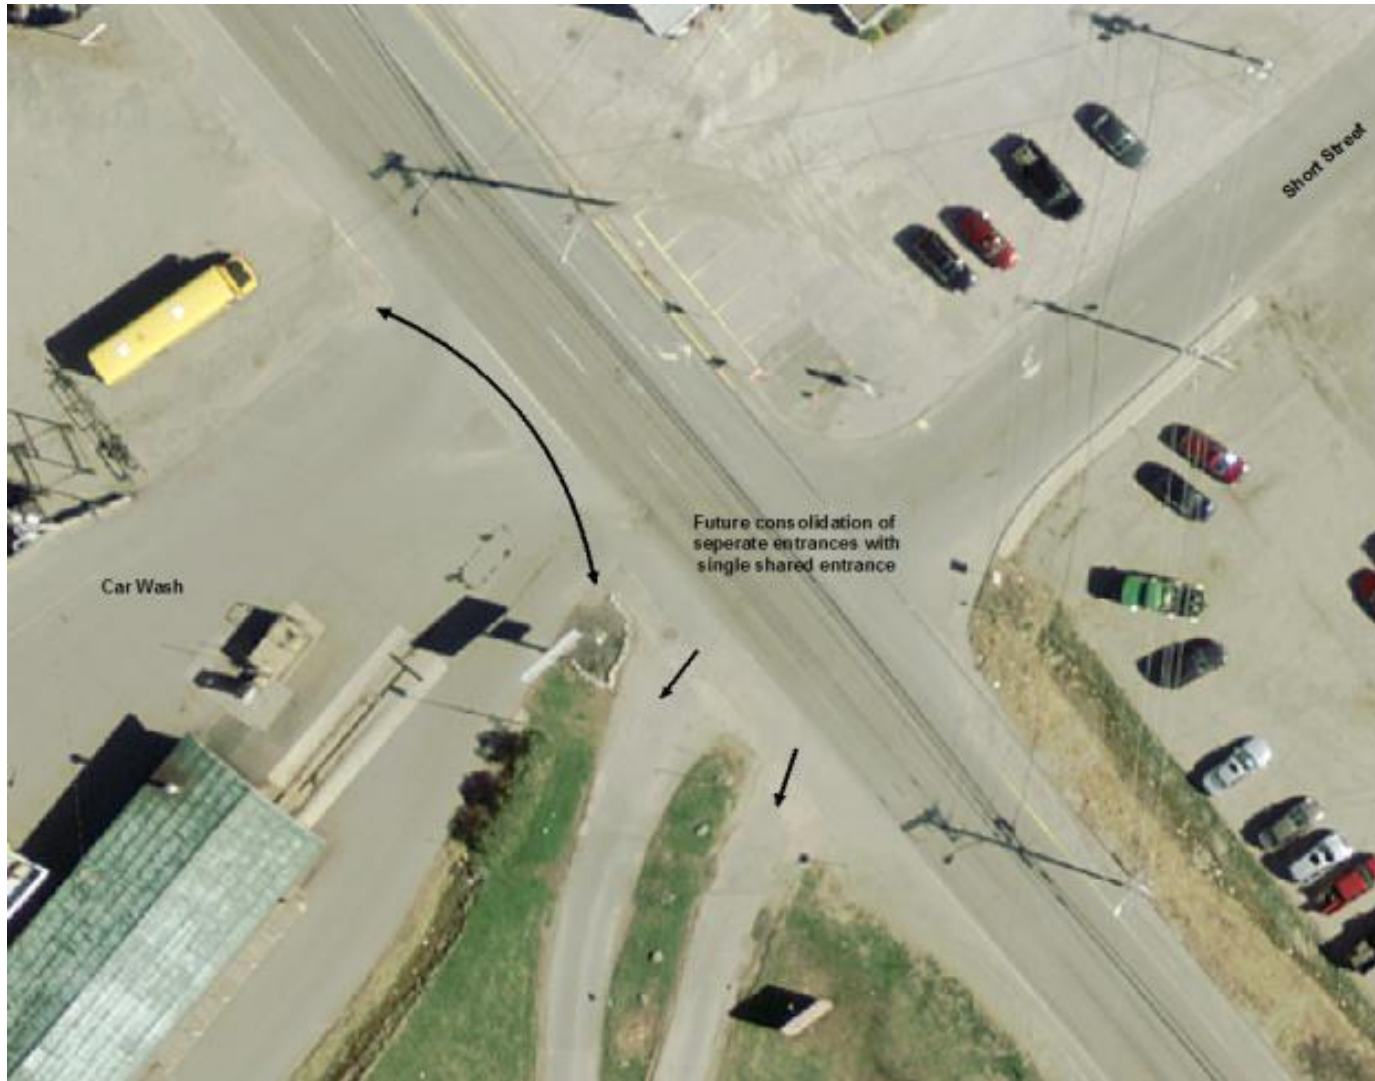
Photo I. Recommendation 4: Future consolidation of High Street business entrances in this area

5. Consider Business Access Changes
 - a. Consider consolidating the separate entrances of the car wash and the veterinary hospital with a single shared entrance of moderate width.
 - b. Consider making the existing entrance to the car wash a restricted right in only entrance.
 - c. Consider consolidating the separate exits of the car wash and the veterinary hospital with a single shared exit (or an exit to access Route 3 to Short Street & a right turn only exit)
