Blue Hill Trail and South St Route

Bicycle/Pedestrian Hazards

These observations were made during an assessment of this route on June 2, 2017.

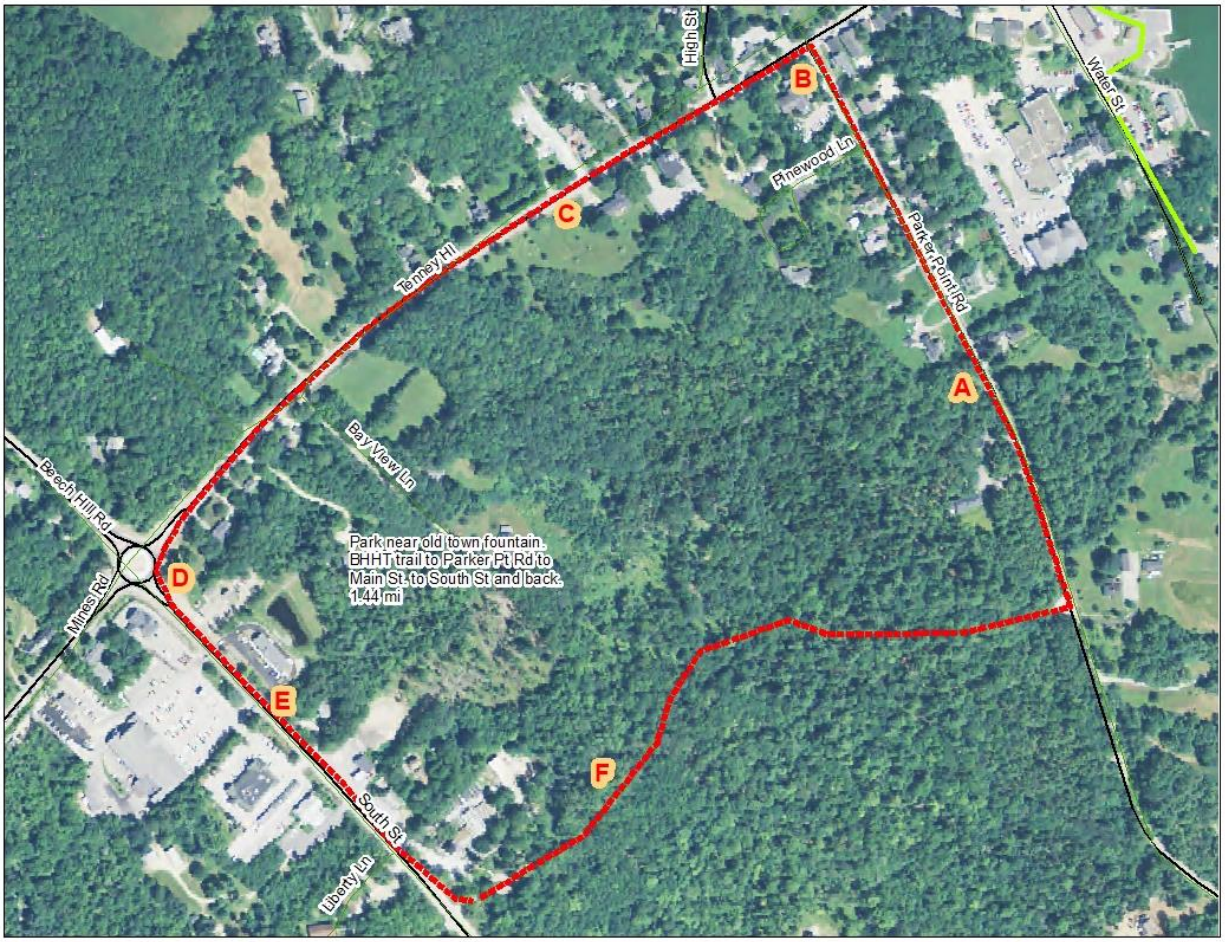
A. There are no sidewalks or painted shoulder lanes on Parker Point Rd., and in some areas pavement is broken and/or uneven.

B. On-street parking on Parker Point Rd. blocks pedestrian access to the sidewalk on Main St.
