Castine Leg Workout Route

Bicycle/Pedestrian Hazards

These observations were made during an assessment of this route on June 2, 2017.

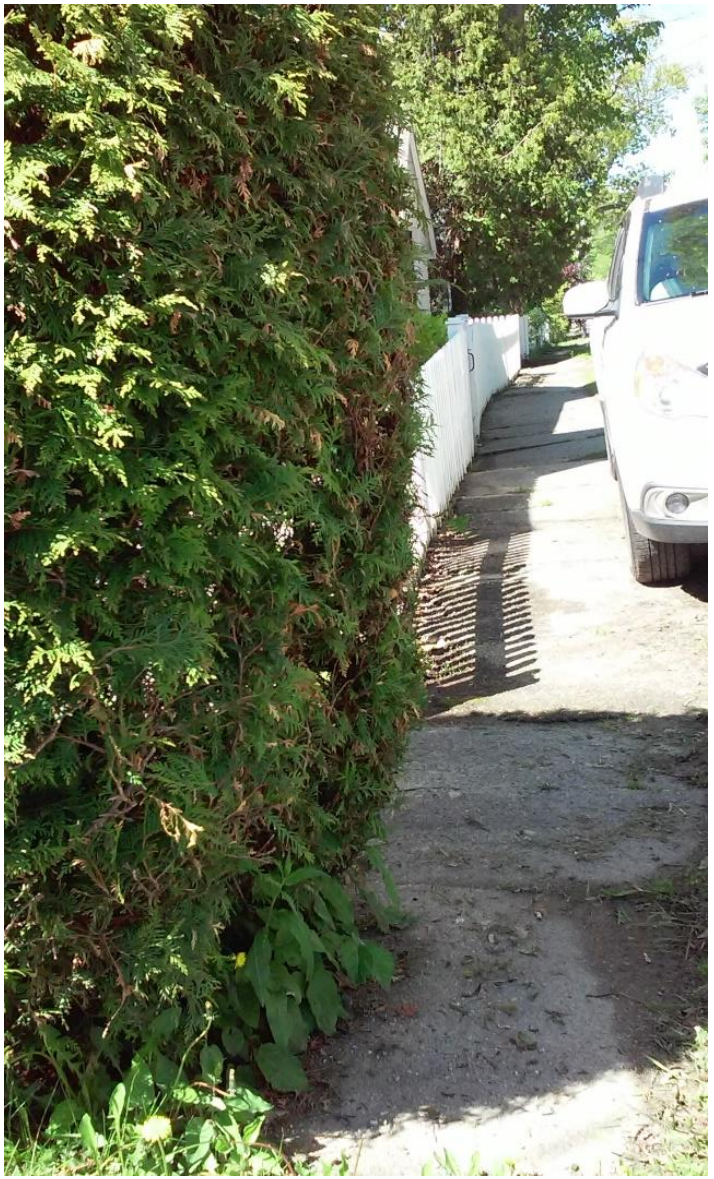
D. The Perkins St. sidewalk between Dressers Ln. and Tarratine St. is in poor condition.

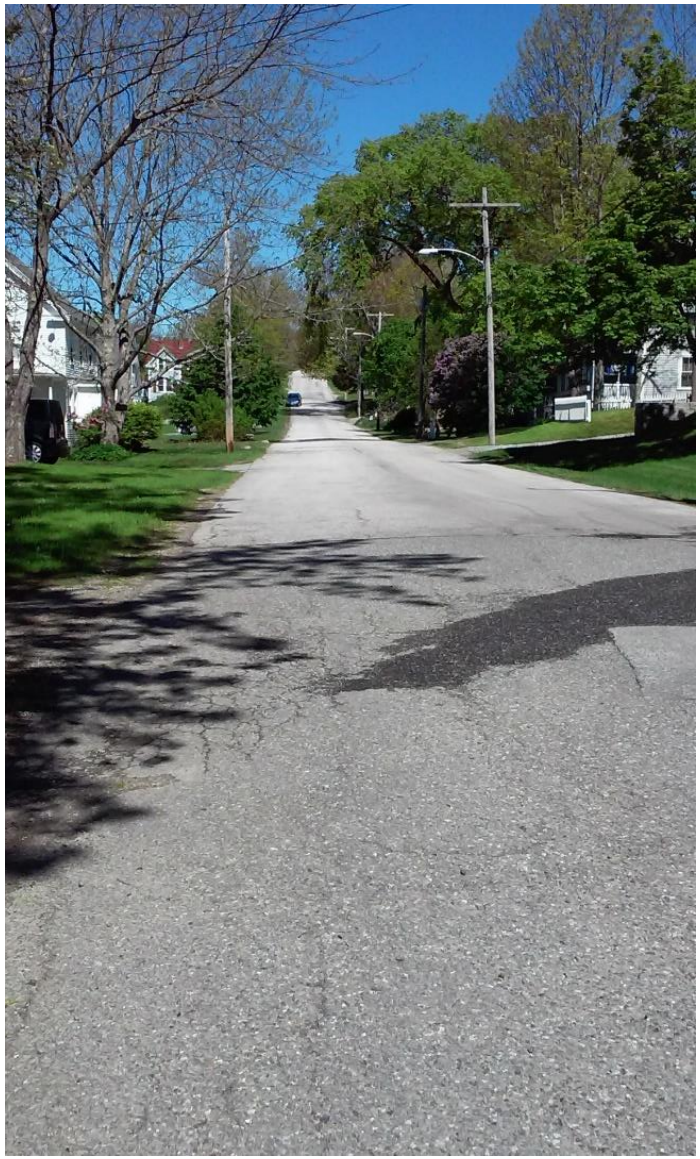
F. There is no sidewalk or painted shoulder on Tarratine St., and potions of the shoulder have broken and/or uneven pavement.

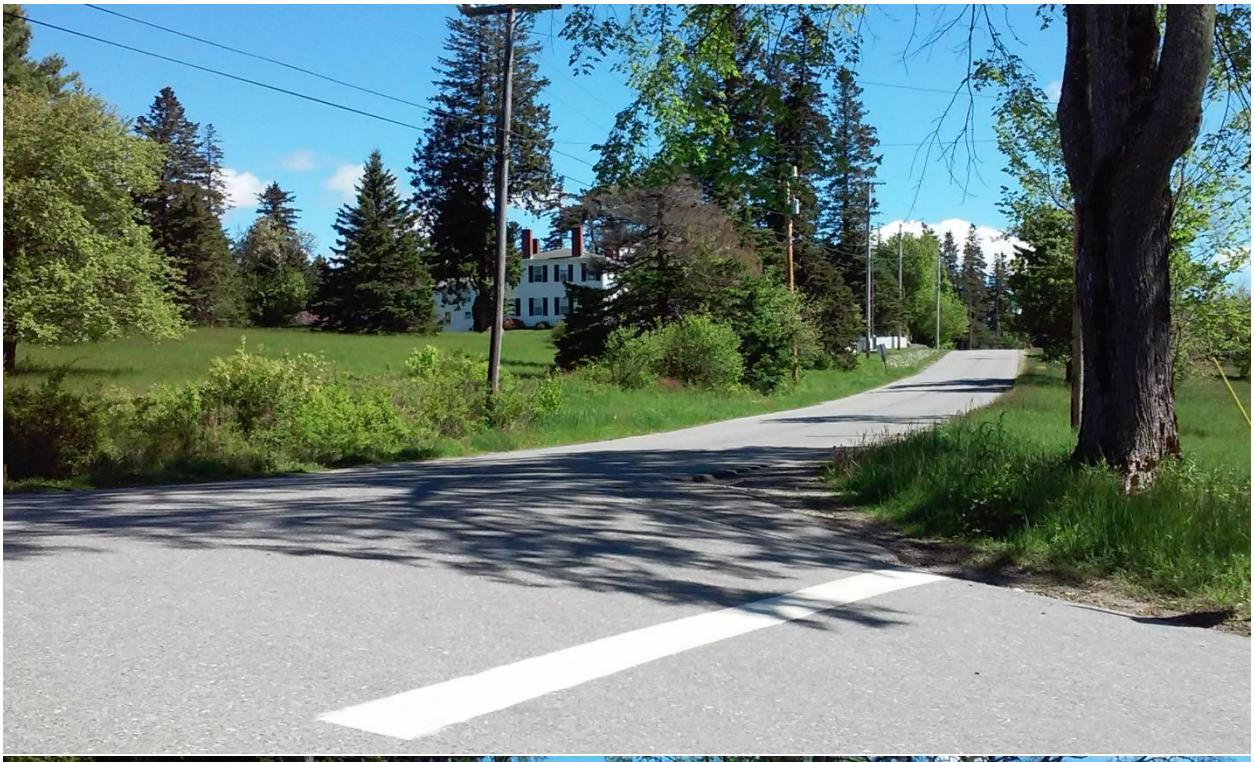
G. There is no sidewalk or painted shoulder on Battle Ave. between Tarratine St. and Main St.
