Castine Water View Route

Bicycle/Pedestrian Hazards

These observations were made during an assessment of this route on June 2, 2017.

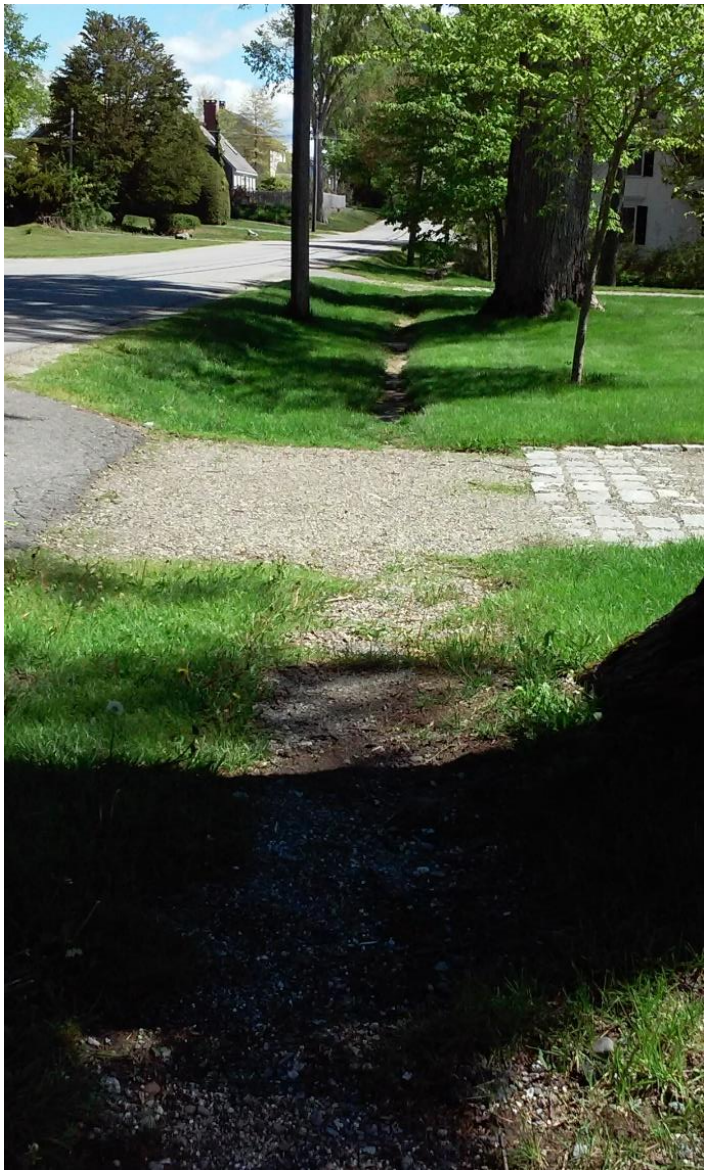
A. The sidewalk on Court St. between Green St. and Dyer Ln. is narrow and in poor repair.
