Franklin

Bicycle/Pedestrian Hazards

These observations were made during an assessment on May 30, 2017.

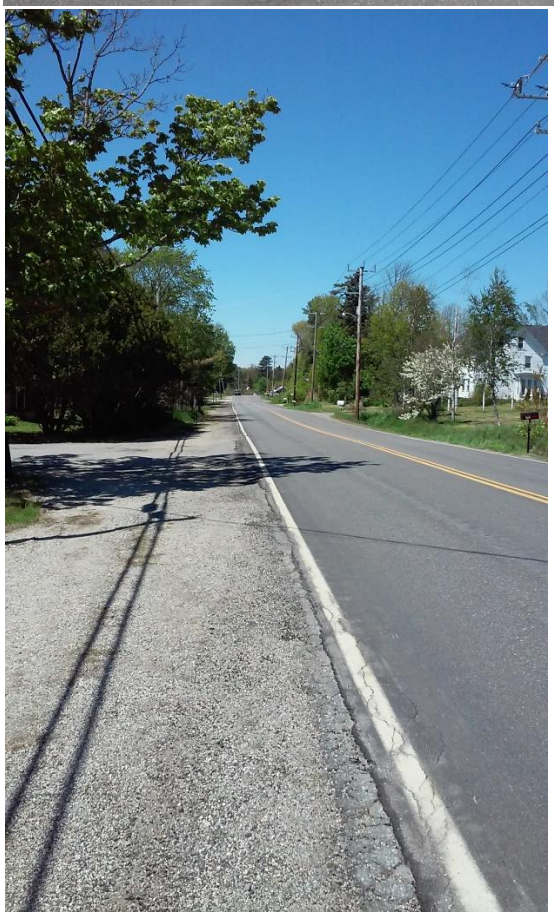
A. Photo taken on Route 200, just north of the intersection of Route 182. Narrow, unpaved road shoulders inhibit safe bicycle and pedestrian usage.
